## **Preventive Maintenance in Vocational Schools in Malang City, Batu and Malang Regency**

**Keywords:** preventive maintenances, school buildings

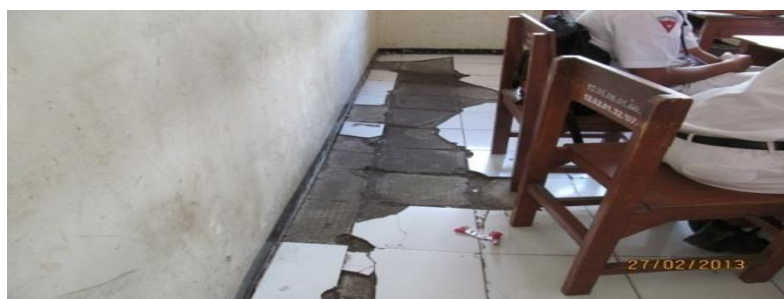
Figure 2 Medium Damages

Rooted in the levels of damage, school buildings in Malang Regency have the highest numbers of damage. There are 8 severely damaged buildings spread in 24 schools, 3 buildings spread in 6 schools in Batu City and only 1 severely damaged building in Malang City spread in 21 vocational schools. In the area of Malang regency, there are 23 buildings with medium damages spread in 24 schools, while in Malang City, there are 7 buildings with medium damages spread in 21 schools. Moreover, in Batu City, there is no building with medium damage spread in 6 schools.

- 3) Malang Regency has the highest numbers of building with medium damages. There are 23 rooms from 24 schools with medium damages. In-depth interviews result in the fact that generally schools know about the damaged buildings' conditions. The medium damages in these schools include popping floors many cracked floors, cracked wall plasters, fallen ceilings and many supported hanger ceilings. These medium damages have the tendency to endanger students during the teaching and learning processes. In this phase, improvements cannot be put off anymore. They cannot be procrastinated. They have to be conducted now. It is due to the fact that procrastination in repairing the damages will put the students and teachers using the rooms in danger.

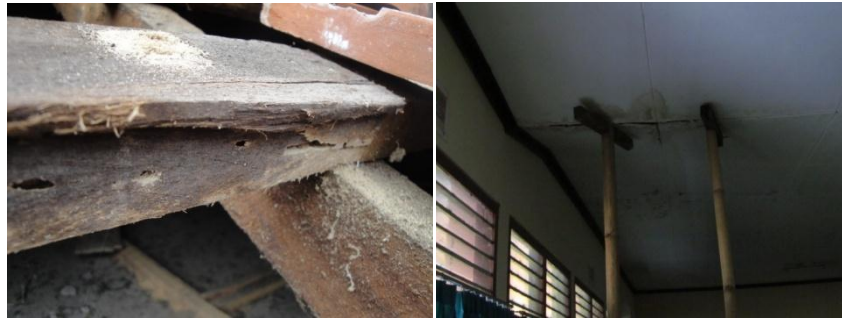
Figure 3. Severe Damages

- 4) There are 8 buildings with severe damages in Malang Regency, 3 buildings with severe damages in Batu City and 1 building with severe damages in Malang City. The damages happen in the form of uneven roof shapes. The arrangements of the roof, when seen from

afar, are bent. It shows that the supporting structures of the room are getting fragile and are, soon, going to fall apart. It frequently is caused by the supporting woods in the roof construction (gantries) are getting fragile. Inside the classes, many hanger ceilings are supported. These severe damages are really dangerous for the students and teachers when they are inside the classes or other buildings such as workshops, laboratories or libraries. These rooms need departing. These buildings cannot be used anymore.

- 4) Vocational high schools that have buildings with severe damaged buildings, for example fractured gables, fragile girding caused by moths, bent rooftops, should not be used anymore. Severely damaged buildings just have to wait for time to be fallen apart. It can happen anytime. It may happen the day after tomorrow or next month. Severely damaged buildings need to have fences so no one will enter the buildings in the future.

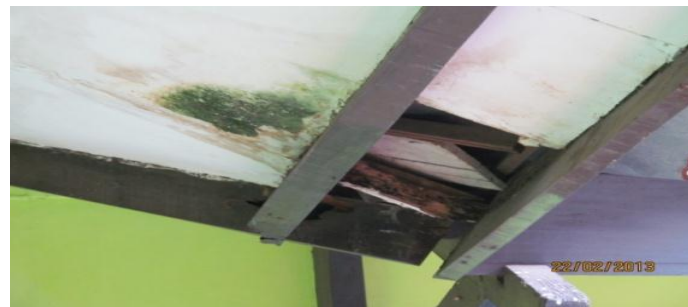
Figure 1. Minor Damages

Anchored in Table 3, there are more buildings with minor damages in school buildings in vocational schools in Malang City compared with school buildings' conditions in Malang Regency and Batu City. There are 604 buildings with minor details in Malang City spread in 21 schools. If rated based on the level of minor damage, Malang Regency comes first with 316 buildings spread in schools, then Batu City with 80 damaged buildings spread in 6 schools.

- 2) Malang City has 604 buildings in public and private vocational high schools with minor damages spread in 21 schools. These damages consist of fallen *lips plank*, doors and windows with broken mirrors or stuck hinges, broken gutters or cracked floors. These damages have to be quickly repaired in order to prevent them from spreading out. By conducting preventive maintenances when the damages are still minor, repairing expenses (workers' wages, building materials and repairing time) will be able to be minimized so they will not strain schools' financial.
